CORROSIVE INTERACTIONS OF GRAPHITE-BEARING SiC-CRUCIBLES DURING COPPER PROCESSING

Denise Ramler – 11th Freiberg Refractory Forum – 09.12.2020

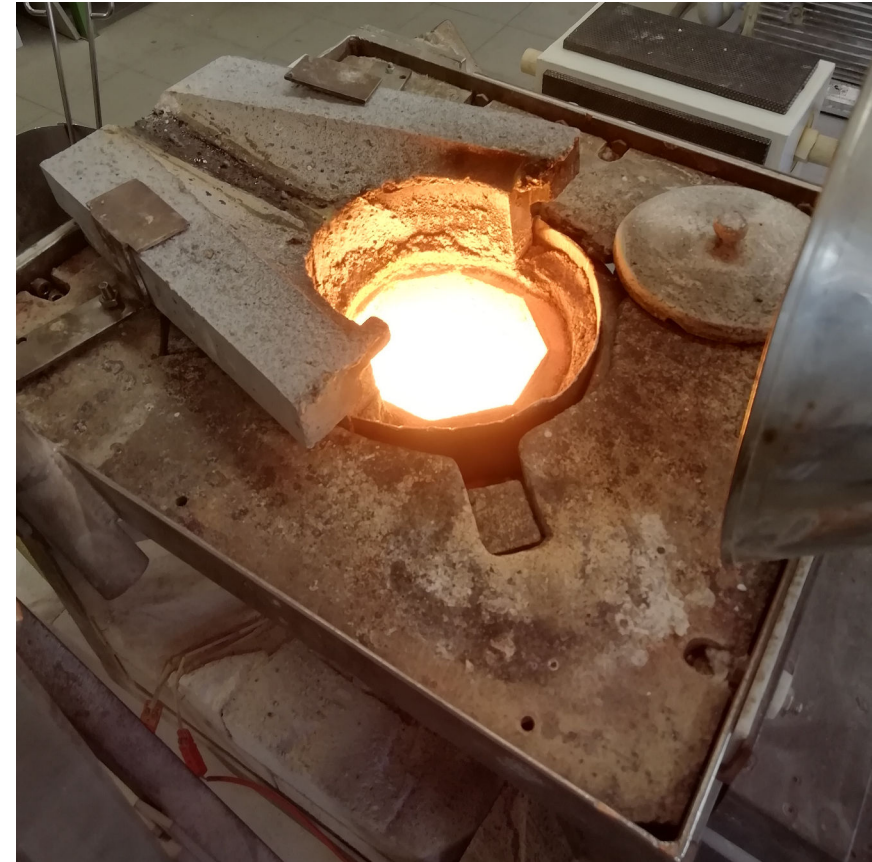
Fig. 1: Induction Furnace Test Setup

- Induction Furnace Test at $T = 1400^{\circ} \text{C}$
 - Testing of all 4 materials simultaneously
 - Impact of atmosphere, slag and Cu-Al alloy on refractory
 - 12h for fluoridic slag
 - Measuring erosion and infiltration depth
- SEM + EDX analysis before and after testing
- X-Ray Diffraction before and after testing
- Thermodynamic calculations via FactSage

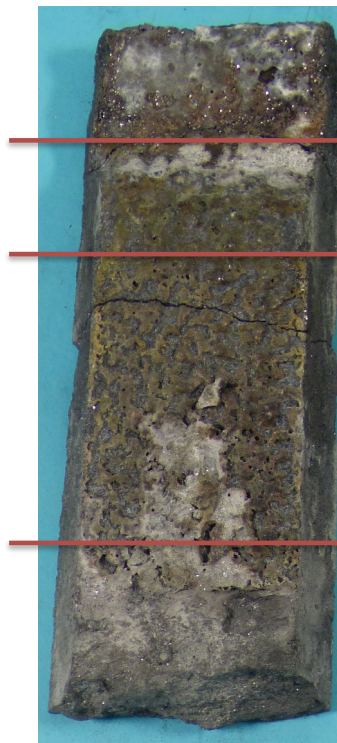
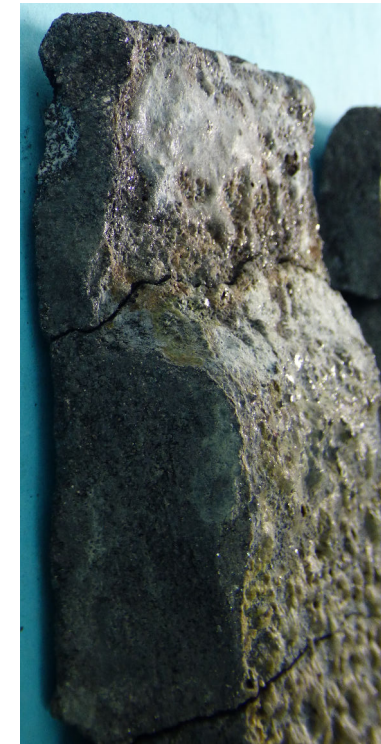
After test with fluoridic slag

Zone O

Zone S

Zone M

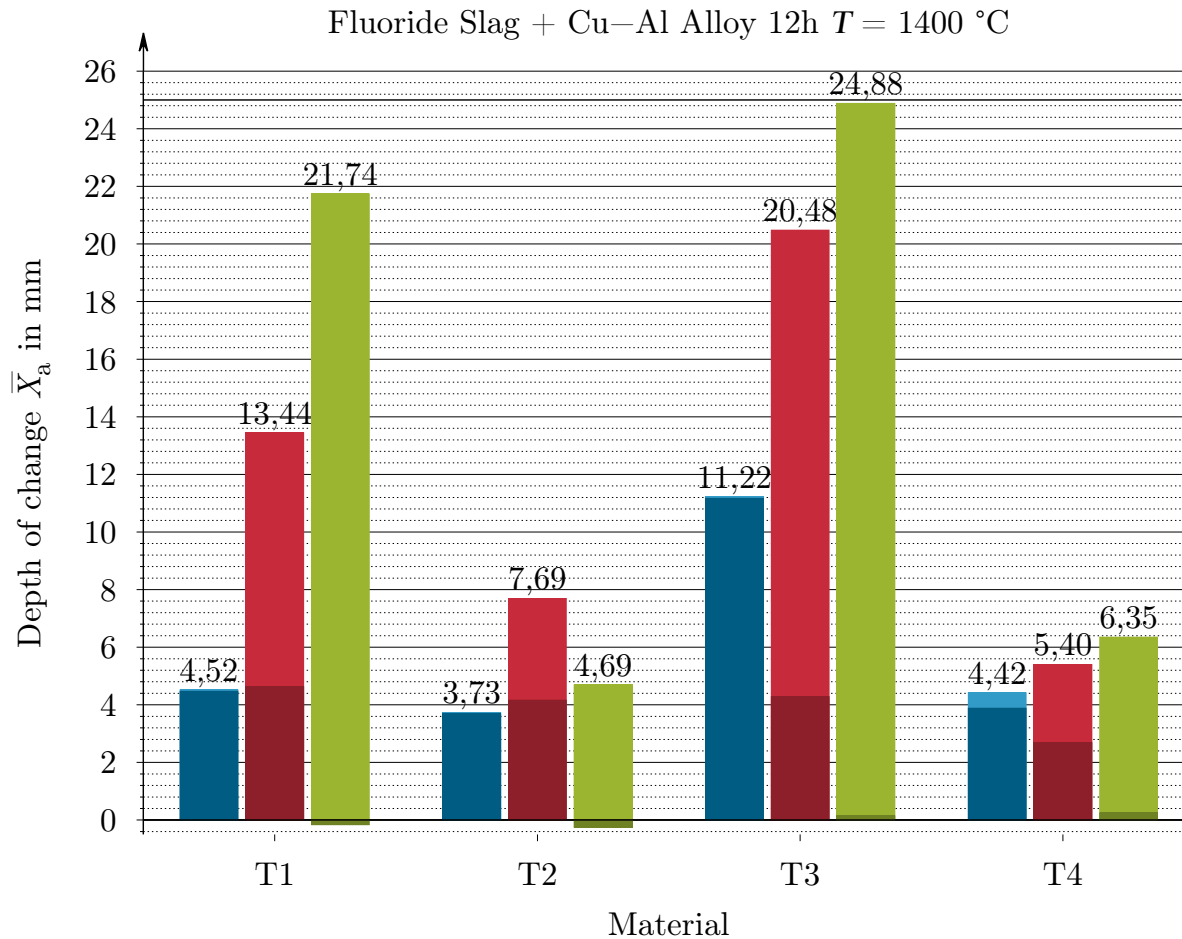
Fig. 2: Depth of change in mm. Consists of depth of erosion + slag infiltration.

Zone O ■ Erosion ■ Infiltration
 Zone S ■ Erosion ■ Infiltration
 Zone M ■ Erosion ■ Infiltration

- Significant material loss in **Zone O**
- Significant material loss + slag infiltration in **Zone S**
- No significant material loss in **Zone M** but slag infiltration
- Isostatically pressed crucibles are more resistant against slag penetration than roller-formed crucibles
